## **Appendix G**

### **Existing Site and Facilities Analysis**

Existing Conditions Evaluations:  
Department of Public Works Facility  
470 Dedham Ave

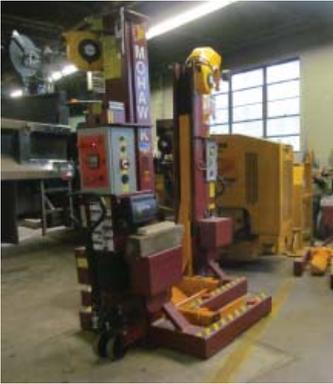
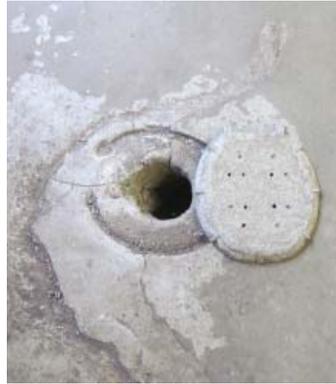
**A1 & A2** - There are currently (2) vehicle maintenance bays, and (1) welding bay. The space is undersized for (5) mechanics based on industry standards that recommend 1.5 maintenance bays per mechanic. There is inadequate lifting height indoors for the Mohawk four post mobile lift currently stored in the vehicle storage area. There is an outdated direct vehicle exhaust system, which include holes located in the slab that vent through the roof.

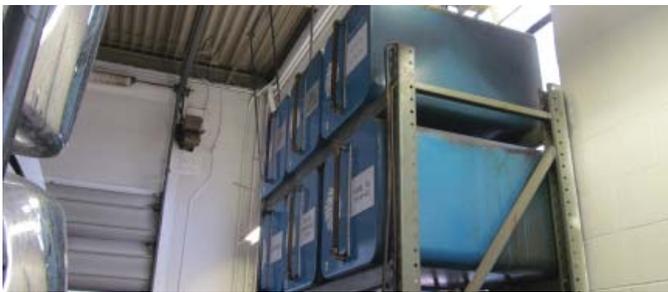
**A3** - Fluids are not stored in a properly rated room with spill protection per CMR 527 9.0.

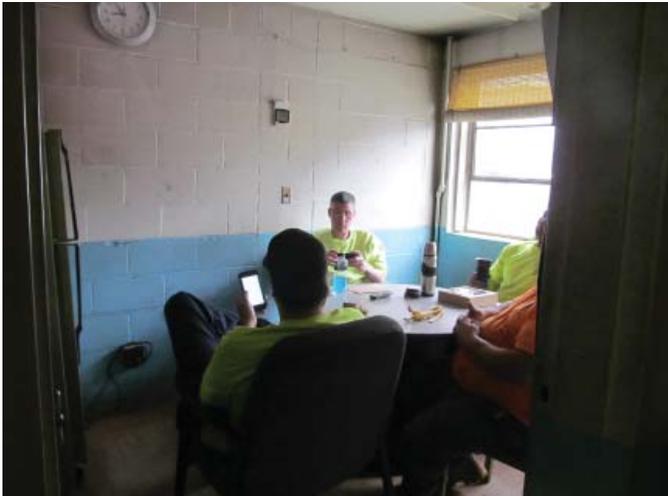
**A4** - The mechanics toilet and kitchen facilities are not code compliant by today's standards, and not sized adequately for (5) mechanics, a refrigerator, TV, and microwave that have been added to space. There is no counter space in the mechanics break room.

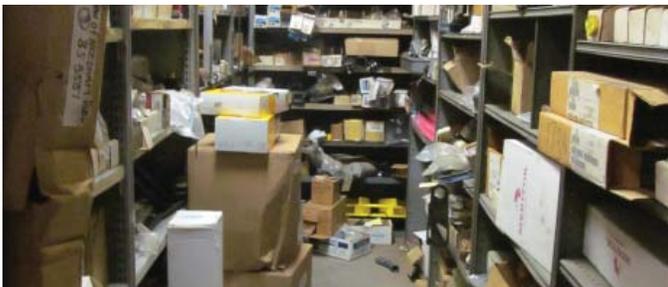
**A5** - The corridors and parts storage areas have been converted into office space and storage for reference manuals. The remaining parts storage area is inadequate resulting in parts being stored on the maintenance floor and in corridors causing "stacking" of tires and parts in an inefficient manner that is a trip hazard.

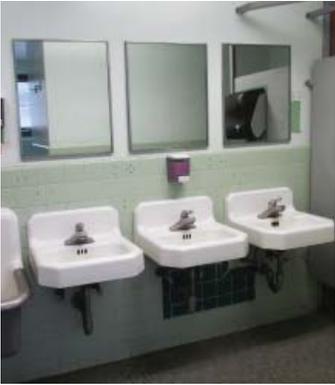
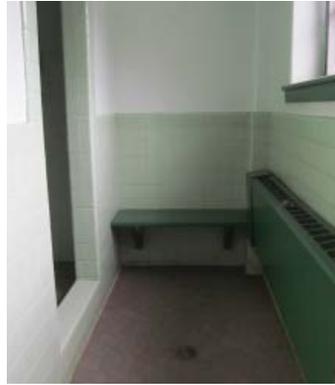
**A9 & A10** - Although the bathroom, shower and kitchen facilities likely met the requirements of the codes when they were constructed, they do not conform to current State Building Code, Plumbing Code, and ADA Guidelines.

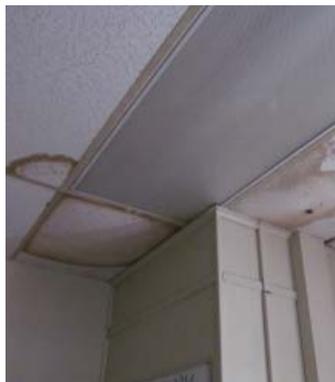
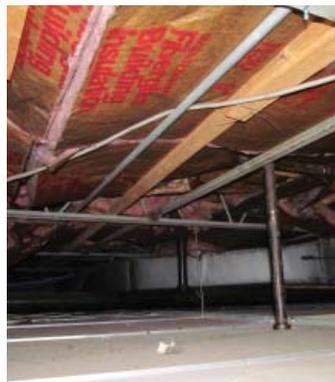
**A12 & A13** -There is evidence of water infiltration near the chimney in the Highway Division muster room. Window air conditioning units have been added to many rooms suggesting that the roof top units no longer work. After removing ceiling tiles in the former engineering department we found batt insulation on wood furring between the roof joists.

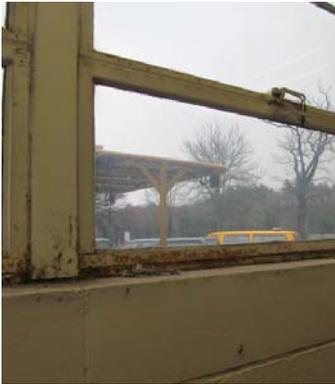
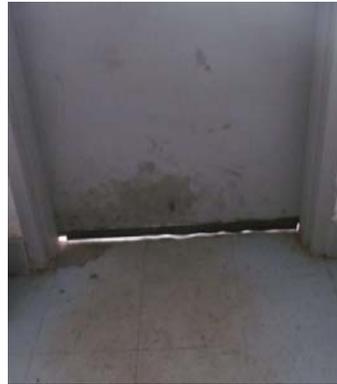
**A14** -The windows throughout the building are energy inefficient single pane windows with steel frames. Many of the window frames show significant signs of rust and deterioration. The hollow metal and aluminum entrance doors are loose fitting and without perimeter weather-stripping making them energy inefficient.

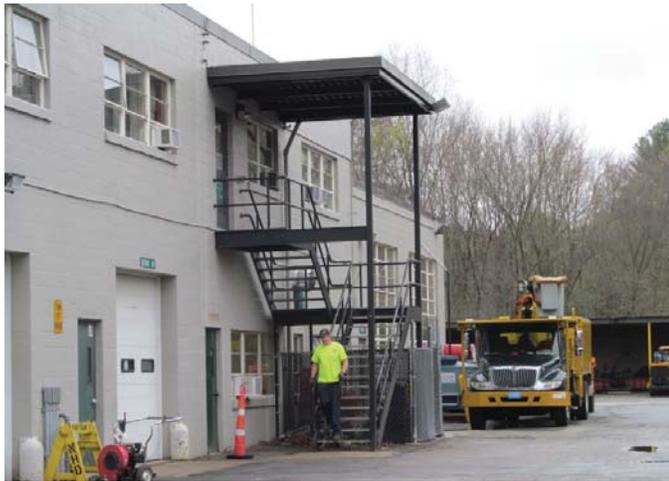
**A15** -The two stairways do not meet current State Building Code standards for design and are not enclosed in a properly rated means of egress system. There is no elevator in the building, consequently it does not conform to CMR 521.

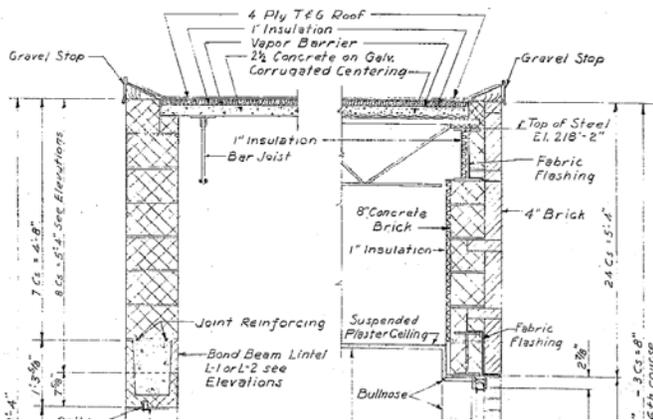
**Roof** -The ballasted roof is past its useful life span, as evidenced by signs of water infiltration in multiple areas of the building. There is water pooling around the roof drains, and moss growing in some areas. The gutters and downspouts are clogged with leaves. The design drawings show minimal or no insulation at roof and exterior walls that would provide only minimal heat loss benefit by current energy code standards.

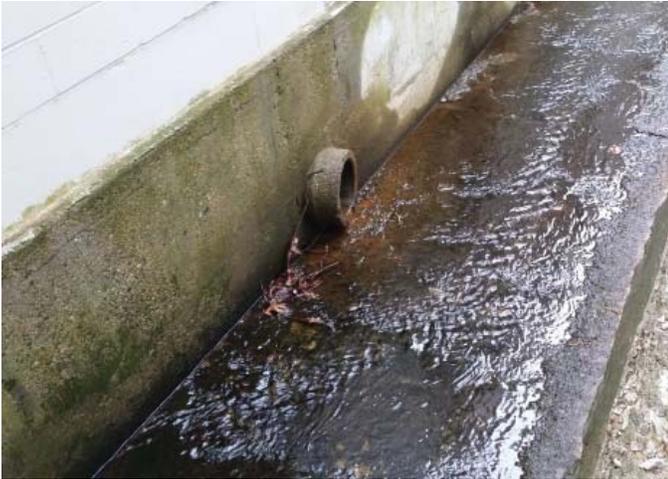
Overall, the building is in fair to good condition. The minor cracking and deterioration found at the existing concrete masonry is expected considering the age of the structure. Existing masonry walls have joint reinforcing every other course and horizontal bond beams. Per the existing drawings, there is no vertical reinforcing. Cracking is likely due to movement from temperature changes. The slabs-on-grade are in fair condition with cracking and minor spalling. There are no signs of settlement. Moderate surface rust was found on the 32L13 joists over the southeast area of vehicle storage that is used as a wash bay. There is some concrete spalling and surface erosion in the drainage channel on the south side of the building.

**S1** - Channel with Deteriorated Concrete and Surface Erosion.

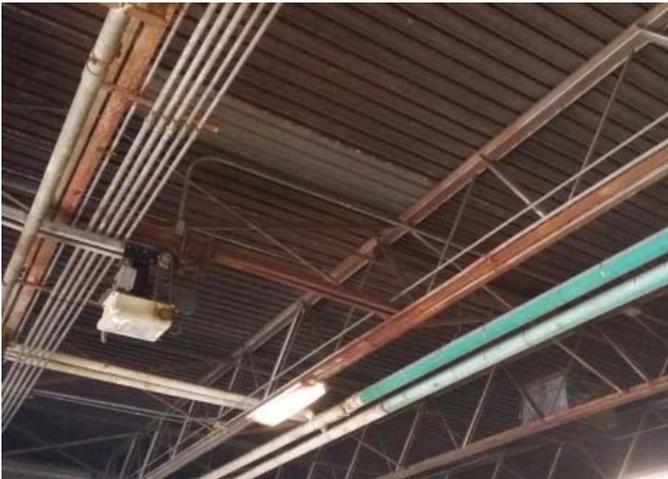
**S2** - Corroded Steel Joists at Wash Bay

- We recommend cleaning and painting steel joists in the vehicle maintenance area.
- We recommend providing vertical structural steel X-bracing to supplement existing concrete masonry walls resisting lateral loading from seismic and wind.

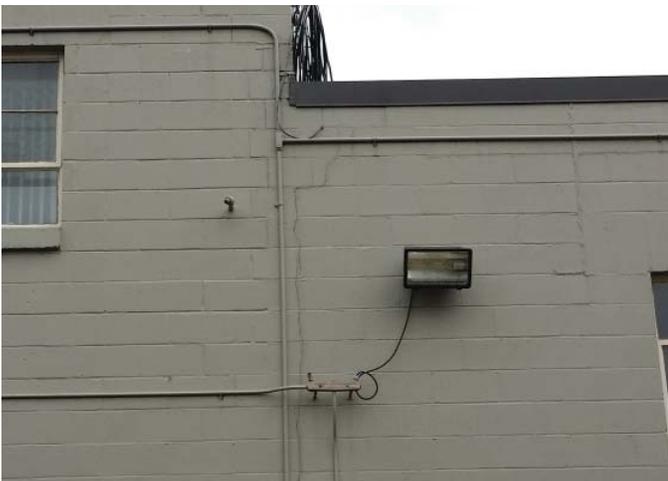
**S3** - Minor Cracking at Exterior Wall

General repairs including, but not limited to, structural crack and spall repairs at existing masonry walls, slab-on-grade repairs, and reinforcing existing roof openings at existing equipment is also recommended. More substantial structural alterations such as removing exterior and loadbearing walls, or adding heavy roof-top equipment may trigger more structural requirements.

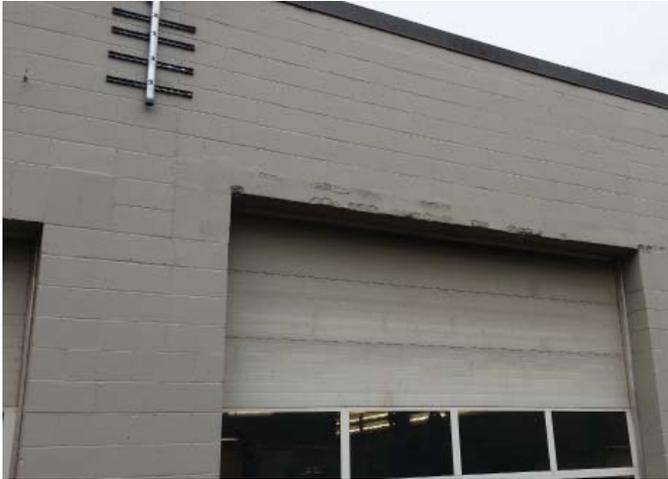
**S4 - Modified Door Opening**

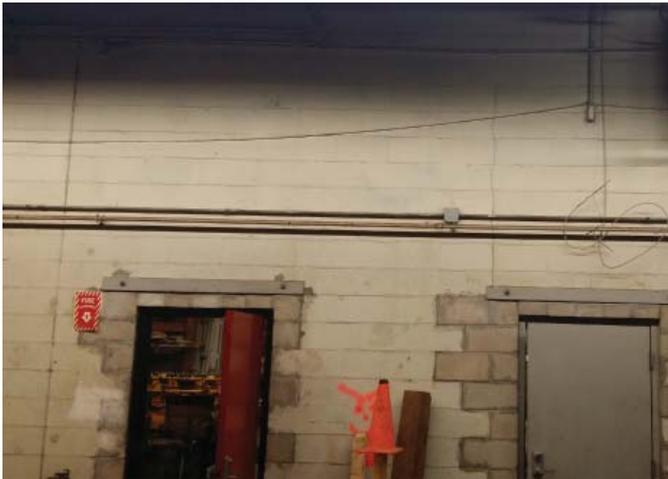
**S5 - New Openings at Interior Wall**

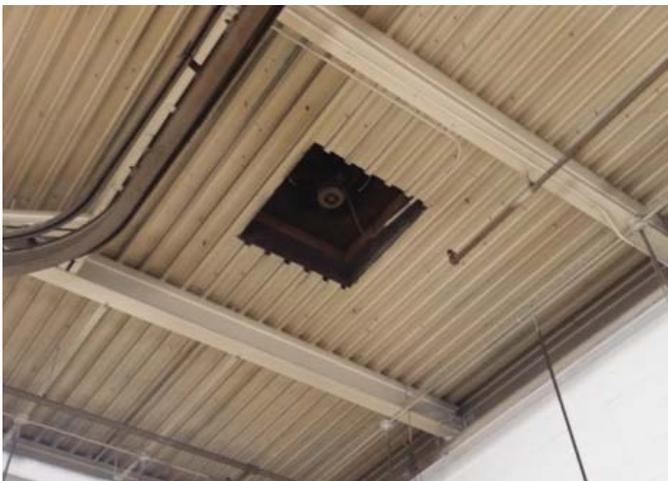
**S6 - Unsupported Roof Opening at Vehicle Maintenance**
