**JOINT MEETING  
SELECT BOARD, PARK & RECREATION COMMISSION,  
BOARD OF HEALTH, SCHOOL COMMITTEE, FINANCE  
COMMITTEE & COMMUNITY PRESERVATION COMMITTEE  
5:30 P.M. February 15, 2023  
Needham Town Hall, Powers Hall + Zoom  
Agenda**

**RE:** Claxton Field Update

**SUBJECT:** Claxton Field Environmental Summary and Improvement Recommendation

Re: **Central Avenue Utility Work Laydown Area  
Claxton Field, Needham MA**

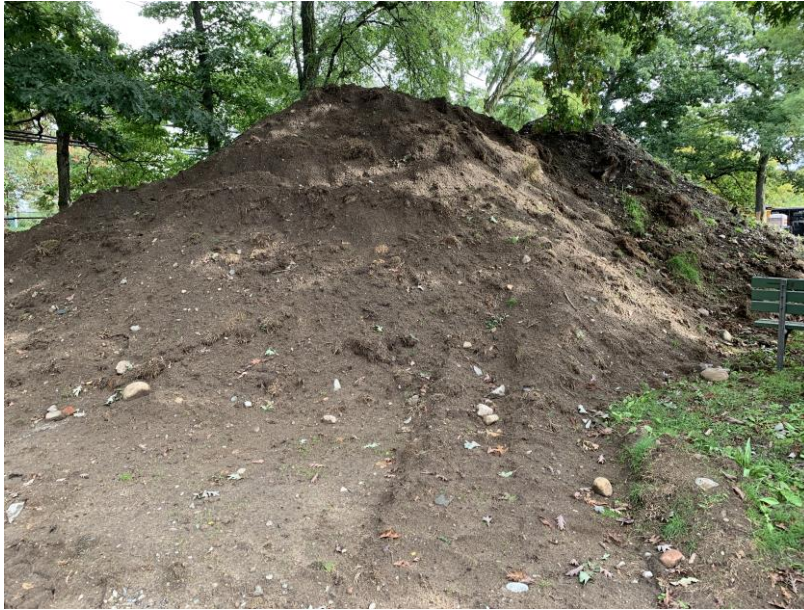
**Photo 1.** Stockpiled topsoil from laydown area.

- Install competent fencing to restrict public access to the laydown area (i.e., conventional construction fencing rather than the existing three-foot snow fence),
- Cover the soil stockpile to prevent migration of wind-blown dust and dermal contact,
- Prevent further excavation into the waste materials to minimize additional disturbance,
- Utilize dust control measures, potentially including wetting of the exposed soil surface during soil handling,
- Remove visible soil from truck tires prior to leaving the laydown area, and perform additional street sweeping, as needed, and,
- Following spreading of the stockpiled soil at the end of construction, place at least six inches of additional imported loam over the previously stockpiled soil prior to reseeding the area during the 2023 spring growing season.

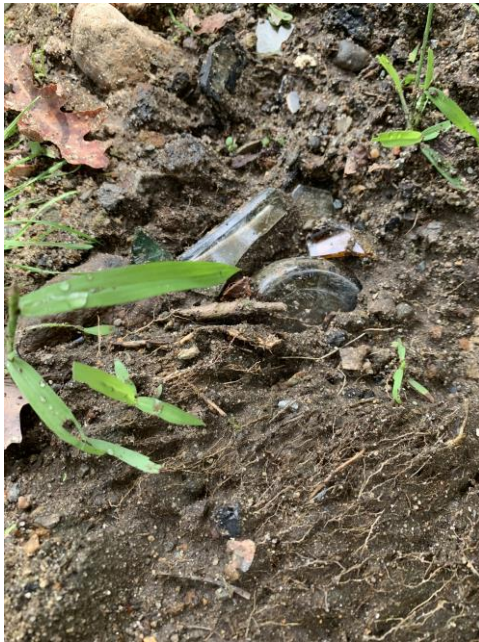
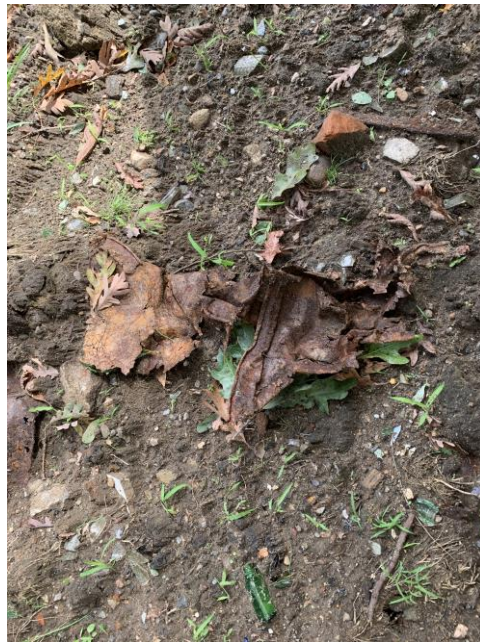
On September 27, 2022, Weston & Sampson mobilized to the site to observe the laydown area and stockpiled materials. A photolog documenting conditions at the time of our reconnaissance is provided as Attachment A. The laydown area consisted of bare earth, surrounded by three-foot snow fencing on the southern side, and the existing chain-link fencing on the northern side along Central Avenue. An approximately 200 cubic yard stockpile site soil was observed adjacent to the entrance gate, which contained visible glass, brick, and metal fragments. These materials were considered to represent approximately less than 5% of the stockpile volume. The stockpile was not covered at the time of our Site visit. No ash or other evidence of waste materials was observed beyond the above.

**Photo 2.** Glass, metal debris observed in stockpiled topsoil.

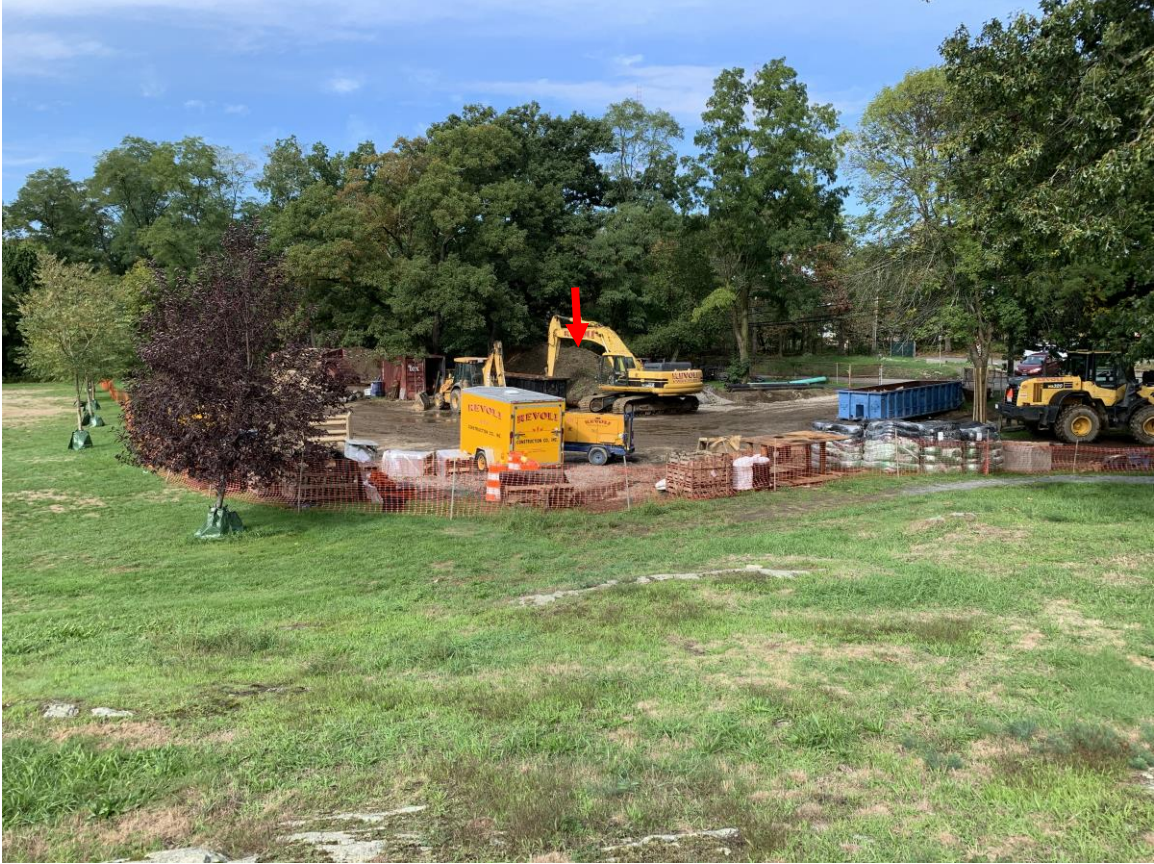
**Photo 3.** Laydown area overview, stockpile indicated by red arrow.
