## **Appendix G**

### **Existing Site and Facilities Analysis**

Existing Conditions Evaluations:  
Department of Public Works Facility  
470 Dedham Ave

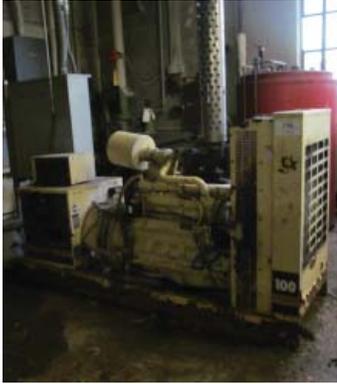
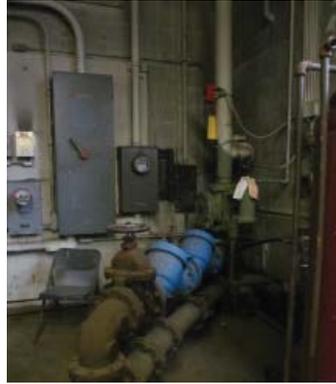
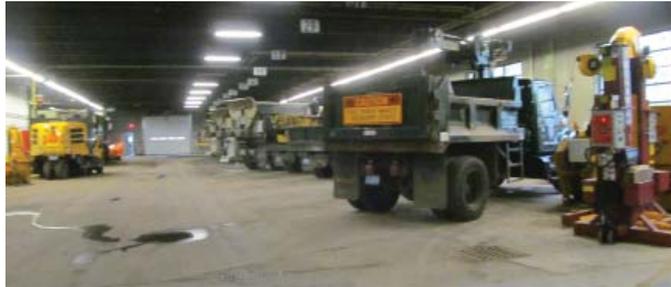
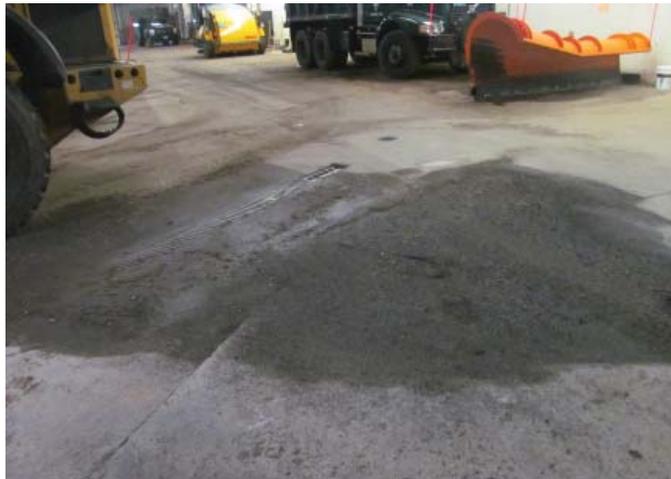
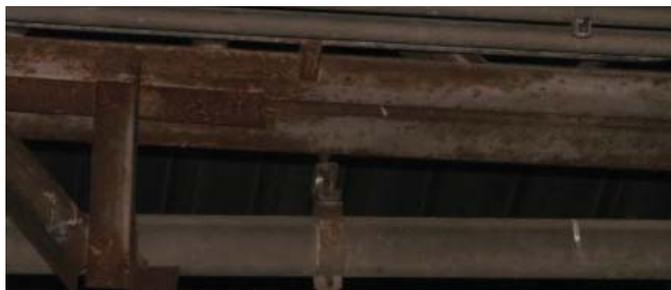
**A6** - The vehicle storage area has poor lighting and ventilation conditions and houses the buildings diesel stand-by generators', and back flow prevention. There is an additional closed storage shed and outdoor canopy for vehicle and equipment storage required for day to day operations. The O. H. doors on the closed storage shed are 8 feet wide and not sized appropriately for today's DPW vehicles and equipment. Vehicles and equipment are stored outdoors without protection from the elements resulting in reduced service life and functionality. The location of vehicle wash area is a safety hazard in close proximity to the generator and main electrical panels without any barrier.

**A7** - There is no wash bay or knockdown pad on site, an area near the exit door to vehicle storage has been converted for washing vehicles. The floor drains and catch basins in this area are not designed for handling the additional water runoff from vehicle washing and often overflow salt and chemicals into the nearby stream.

**A8** - The pipes and structural steel above the area used for washing vehicles show signs of significant rust. Some of the pipes appear to be covered in asbestos insulation, additional testing is necessary to confirm.

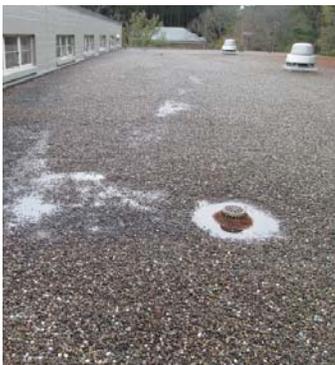
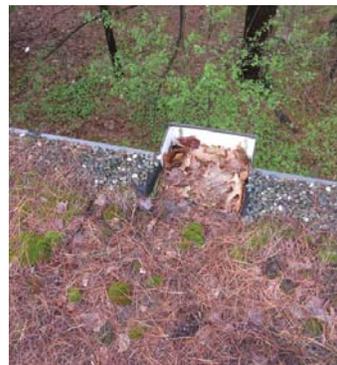
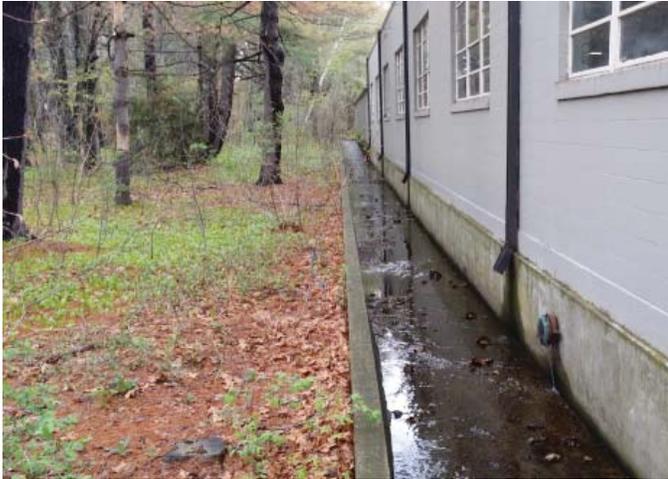
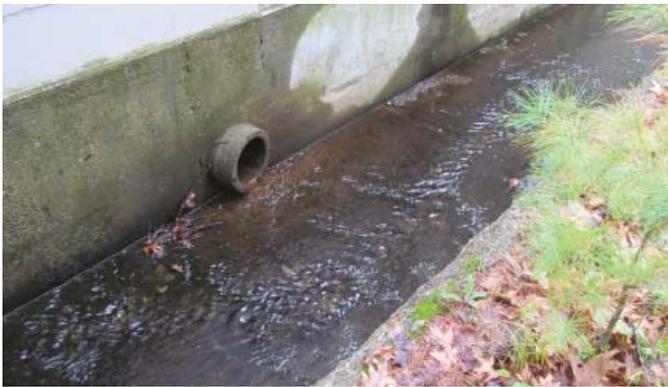
**Roof** -The ballasted roof is past its useful life span, as evidenced by signs of water infiltration in multiple areas of the building. There is water pooling around the roof drains, and moss growing in some areas. The gutters and downspouts are clogged with leaves. The design drawings show minimal or no insulation at roof and exterior walls that would provide only minimal heat loss benefit by current energy code standards.

**Culvert** -A drainage culvert that runs along one side of the building is used to channel roof water run off. In addition to the roof gutters and downspouts there are two drainage pipes that empty into the culvert.

- Replacement of roof, exterior windows, doors, and stairs. Renovating the exterior stair may include simple enclosure rather than replacement
- Addition of an elevator
- Added insulation to the exterior walls and roof to meet current energy standards.
- Reconfiguration of the interior space to meet the day to day operational needs.
- Mechanical systems, lighting, electrical, fire alarm, and sprinkler systems are outdated or broken. Based on our experience, it is likely that these systems will need to be replaced in their entirety.
